# TECHNICAL BULLETIN

T B 0 9 2 3 0 9

## ATRO's UB20500 and New UB20500-OS in the Freightliner Air Liner II Suspension

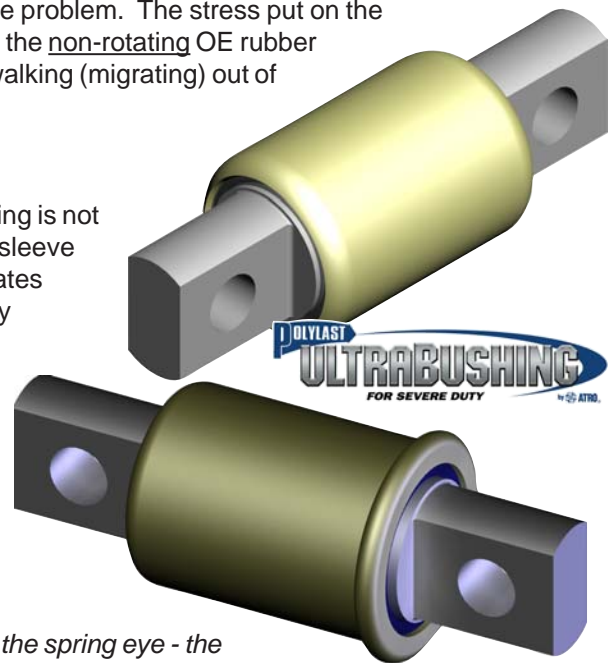
The OE *rubber* pivot bushing, RB205/RB234/RB268, for the Freightliner Airliner II suspension has had problems with the bushings rotating and migrating out of position within the eye of the spring. This was due to the spring eye weakening with stress and use causing the eye to open up beyond the OE specifications. As the eye of the spring gets larger, the grip on the bushing gets correspondingly weaker and the bushing will begin to rotate and walk out of position. The most recent OE *rubber* bushing design, the RB268, is crimped (one end) with the opposite end flared to prevent the bushing from migrating out of the spring when the eye begins to weaken. However, this OE rubber bushing does not address the root causes of the problem. The stress put on the spring eye and the wear due to the suspension articulation and the non-rotating OE rubber bushing pin results in the entire bushing rotating and laterally walking (migrating) out of position.

**UB20500** with our original unique rotating pin design, if the spring is not worn out and the eye has not already been enlarged, the outer sleeve of the bushing will stay securely in place while only the pin rotates within the body of the bushing. (ATRO's UB20500 bushing only requires approximately 25 - 40 ft. lbs. of torque to rotate the pin.)

**NEW UB20500-OS** – our unique rotating pin design, oversized, anti-walk bushing. This bushing is .060" oversized and takes up the gap in most enlarged eyes. ATRO is offering a one-year warranty on the oversized bushing.

*If any UB 20500 or UB20500-OS is found rotating freely within the spring eye - the entire bushing, not just the pin - the cause is a worn spring eye. **ATRO strongly recommends spring replacement.***
