PREVENTIVE MAINTENANCE: Driveline

OCTOBER 2019

Visual Clues it is time to replace the Torque Rod

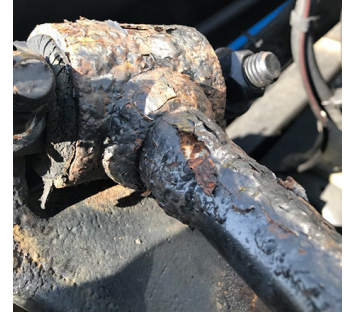
CORROSION

This can be caused by a chemical attack such as acid wash or road treatments.

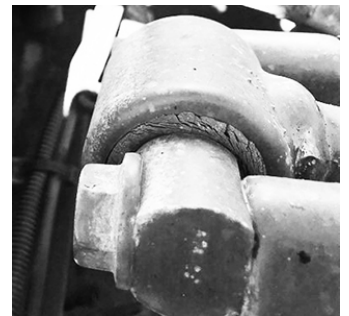
BUSHING WINDUP

This is a condition that is caused when the clocking of the bushing is not correct. It can be seen in rotational cracks at the end of the bushings. While not technically failed, it is an indicator that failure is approaching.

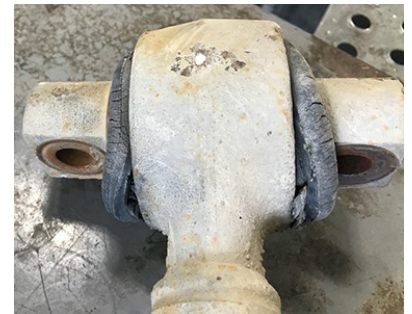
TORN ELASTOMER

This can be caused by overextension beyond the articulation capabilities or repeated shock to the bushing.

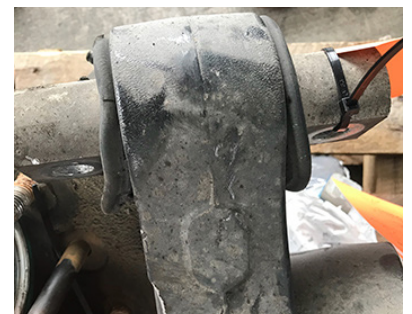
BUSHING EXTRUSION OR DEFORMATION

This can be caused by exceeding the rating of the suspension or contaminants that cause an "oil soaked" condition.

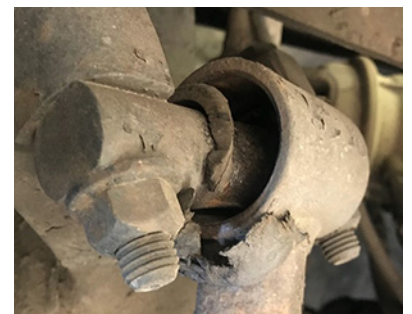
CATASTROPHIC FAILURE

This is usually caused by one of the other issues going unnoticed to the point the elastomer deteriorates completely.

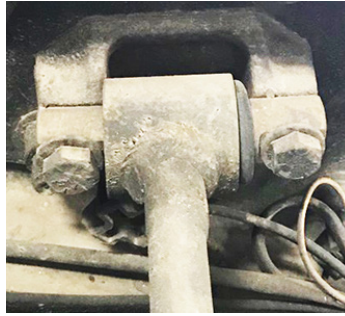
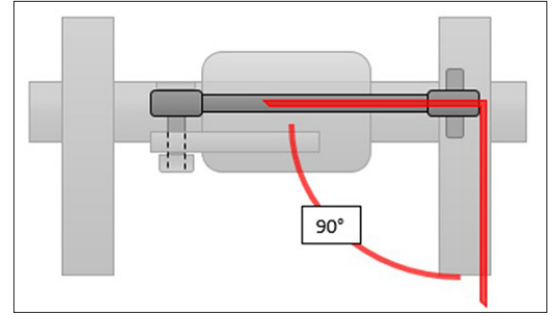
BUSHING WALKOUT

This can be caused when the transverse rod is not perpendicular to the frame rail.

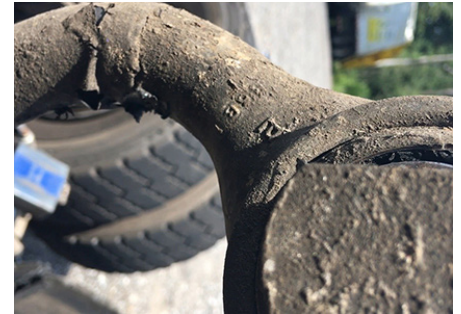
BENT OR BROKEN RODS

This is typically caused by overloading the suspension or impact such as hitting a curb.

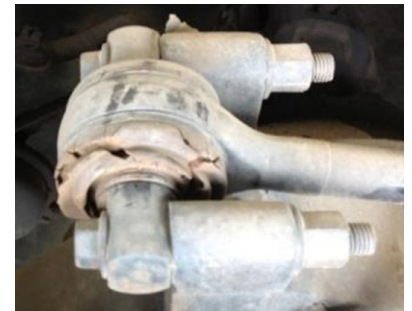
DAMAGED GREASE SEALS

This condition is caused by impact with a foreign object such as road debris or a fifth wheel latch hook.

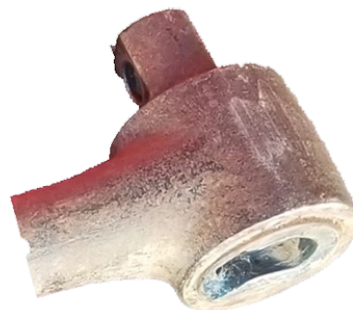
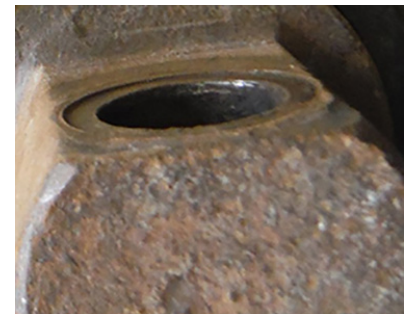
DAMAGED STRADDLE PINS

This can be caused by hardware tightness, misalignment, or impact to the rod.
