Trailer Bumper Test Results

Trailer Bumpers (Length: 5 7/8"; Width: 3"; Height: 3 1/8")

- OEM Rubber Trailer Bumper
- ATRO Polyurethane Trailer Bumper

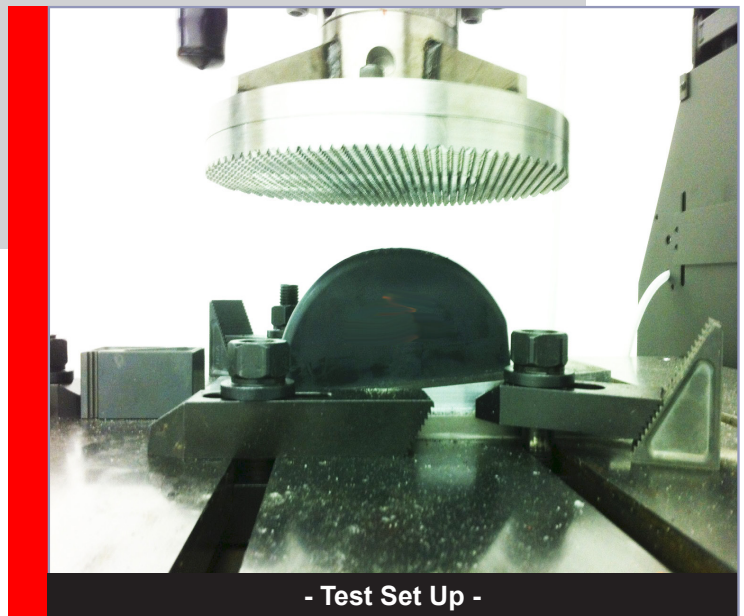
- Test Set Up -

1. Each bumper was bolted to a base plate which had a 5° angle machined on it. This was done to approximately simulate the angle at which a trailer bumper would contact a dock.
2. The bumpers were impacted by a hardened steel plate which had a rough texture machined in it to accelerate wear.
3. Each impact reached a maximum load of 5,000lbs, which was determined based on the load deflection test results.
4. Testing continued until failure or 250,000 cycles was reached.

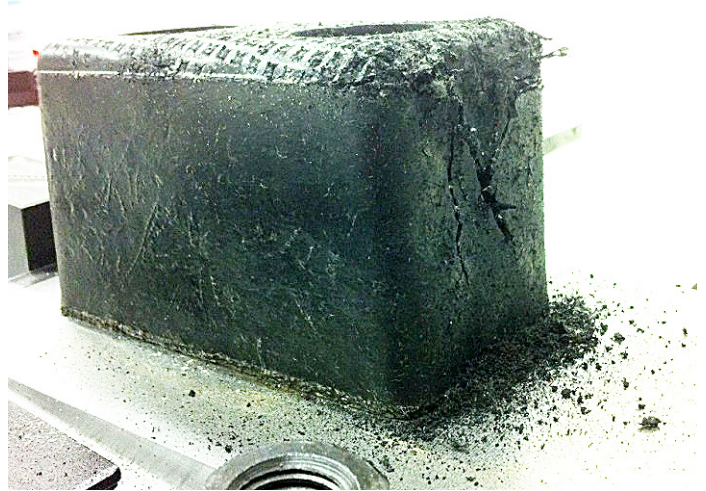
ATRO Polyurethane Bumper at 250,000 cycles

The ATRO polyurethane bumper lasted the full 250,000 cycles without failing.

After testing was complete, there was very little visual damage to the ATRO part.
